AIRCRAFT ACCIDENT REPORT
OPNAV FORM 3750-1 (REV. 3-63) Page 1
0107-601-6985

SECTION A. IDENTIFICATION		SECTION B. CONTRIBUTING FACTORS		SECTION C. PERSONNEL DATA	
1. AIRCRAFT ACCIDENT BOARD APPOINTED BY CO, NAS LOS ALAMITOS		2. SERIAL NO. 3-68A		3. PTS (LOCAL) OF WISHAP 171515U APR 68

4. MODEL AIRCRAFT A-4A		5. BUREAU NUMBER 137828			
6. TO: Commander, Naval Aviation Safety Center		7. LOCATION OF WISHAP 082 DEG. MAG 13 NM FM JULIAN FOR, CALIFORNIA		8. DAMAGE ALFA

13. TYPE CLEARANCE VFR		14. AIRSPEED 340 P	
		15. ALTITUDE 4000'		16. A/C WEIGHT 16,310	
17. BRIEF DESCRIPTION OF WISHAP ENGINE FAILURE - PILOT EJECTED		18. ELEVATION AT TIME OF WISHAP 4000'		19. TERRAIN 2600'

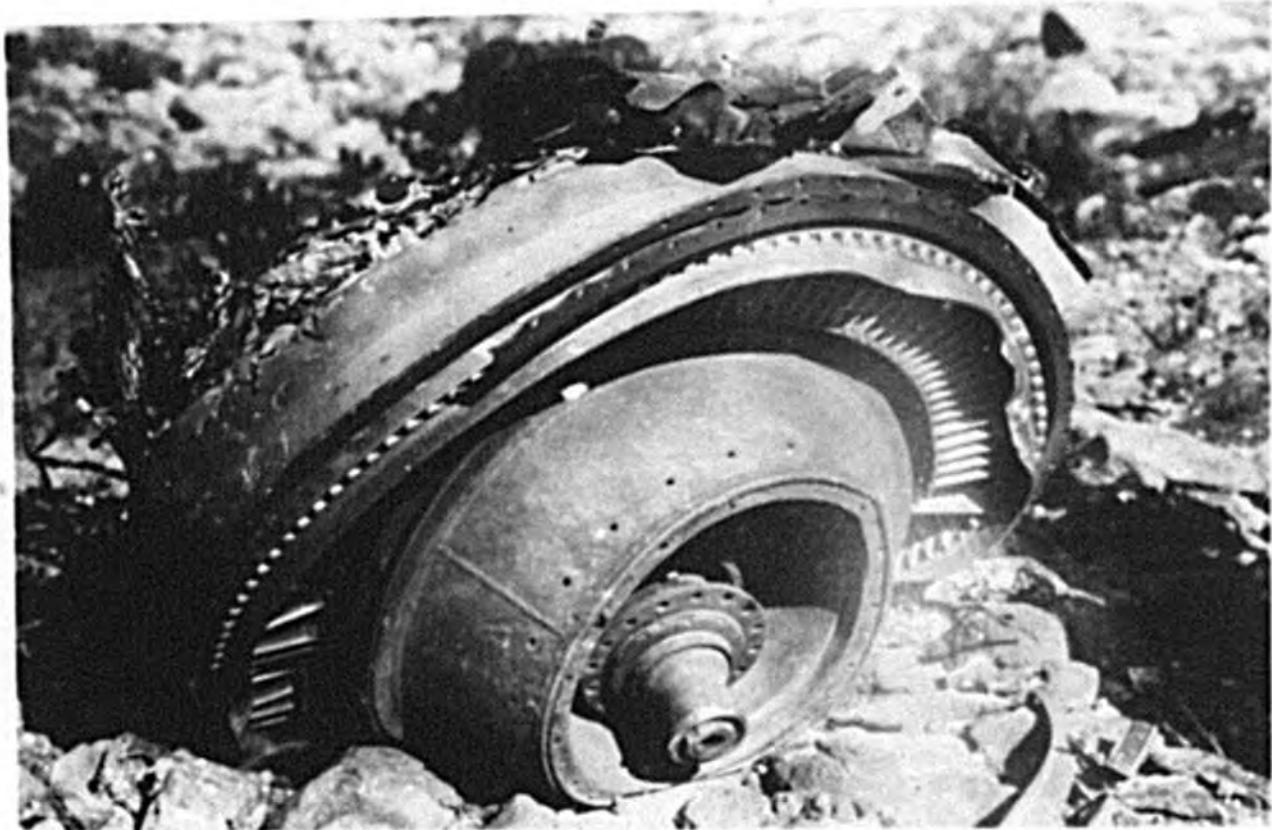
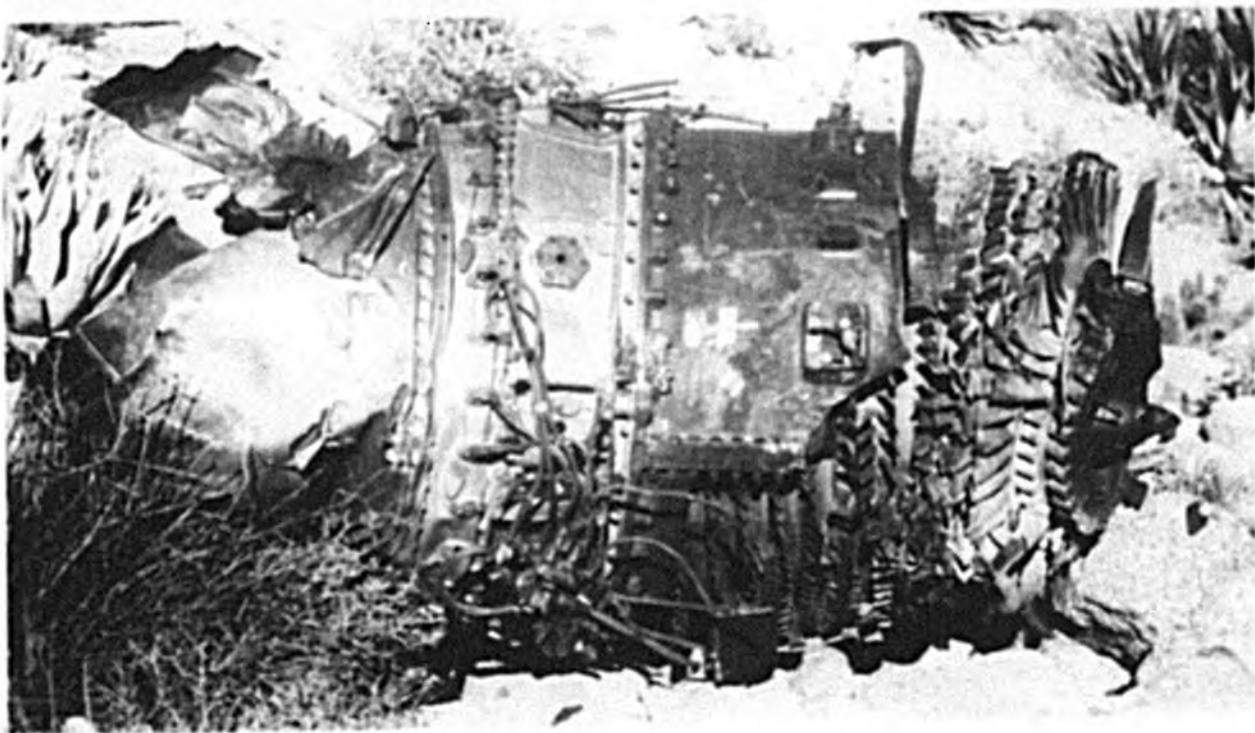
ENCLOSURE (5) COMPOSITE VIEW OF ENGINE AND TURBINE AS FOUND AT CRASH SITE.
NAS LOS ALAMITOS 3-68A, 4-17-68
A-4A, BU NO 137828, pilot SHAFER, VA-773
SPECIAL HANDLING REQUIRED LAW OPNAVINST 3750.6 SE 15

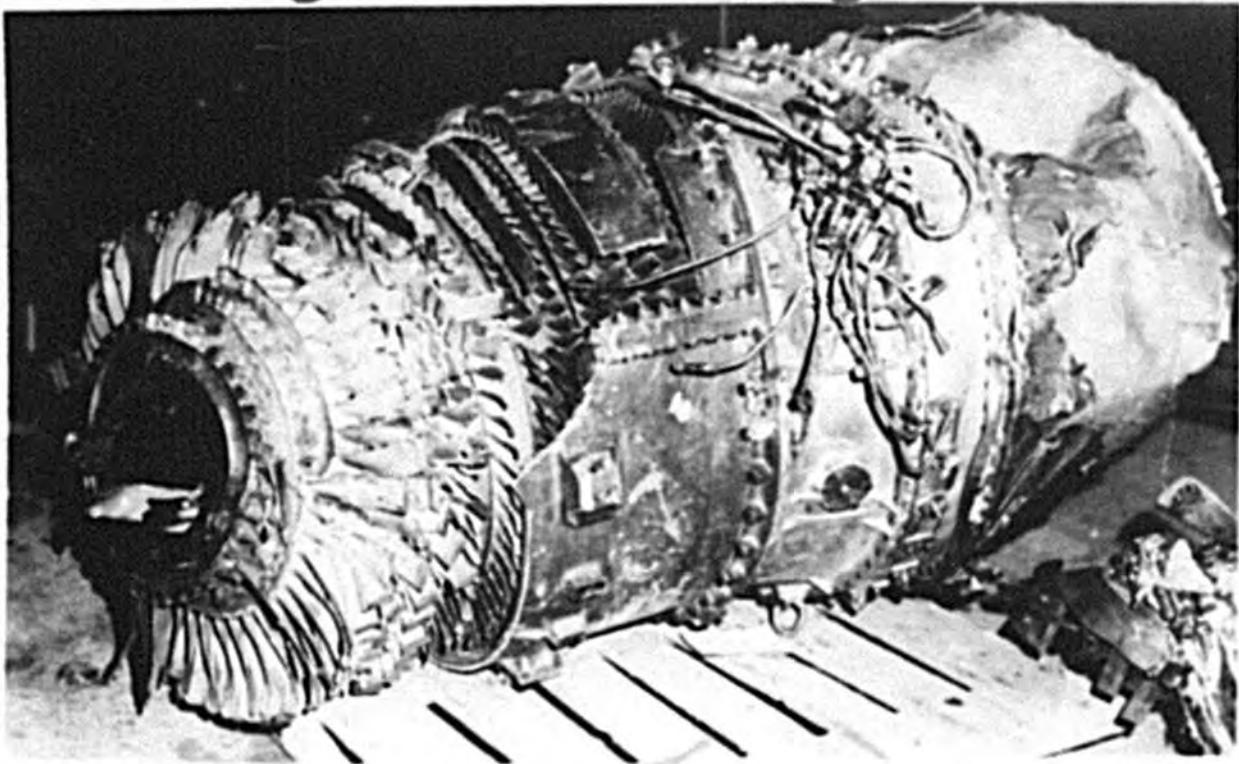
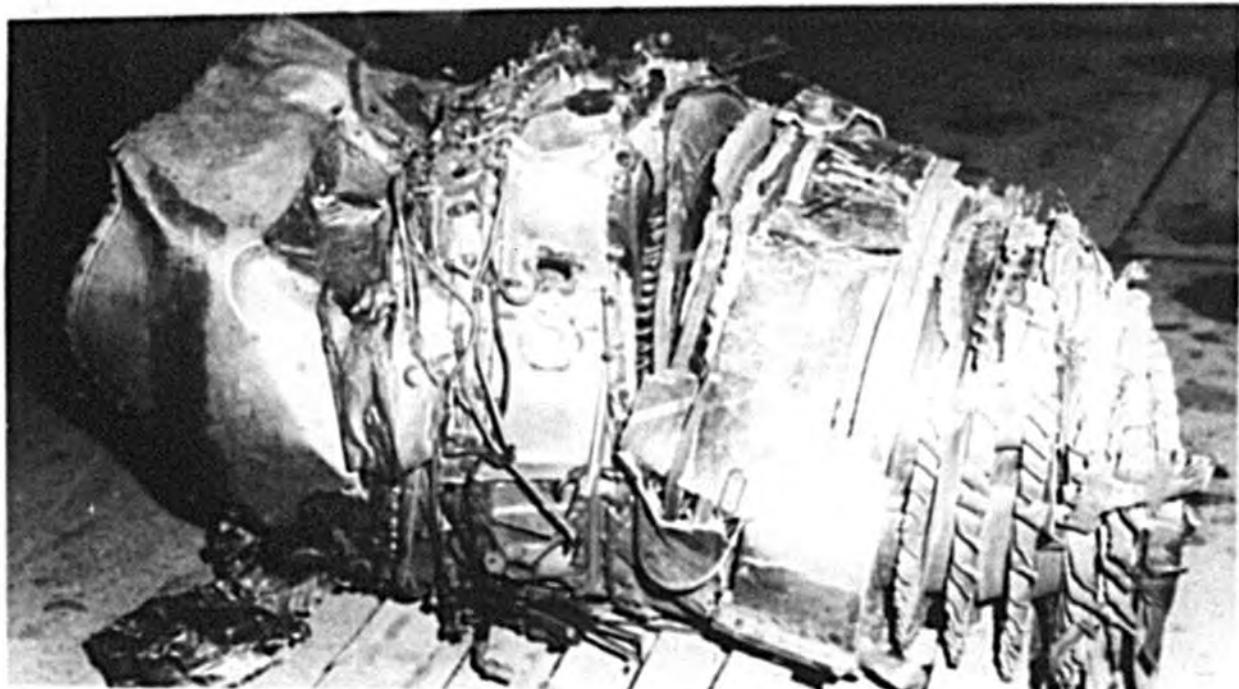
ENCLOSURE (6) COMPOSITE PHOTO OF ENGINE COMPRESSOR SECTION.
NAS LOS ALAMITOS 3-68A, 4-17-68
A-4A, BUNO 137828, pilot SHAFER, VA-773
SPECIAL HANDLING REQUIRED IAW OPNAVINST 3750.6 SERIES

C. NAS LOS ALAMITOS AAR 3-68A
D. FORCON D. BAKER NAVAIRSYSCOMREPAC AND C. DAMGAARD THIS FACILITY
ON 30 APR 68
1. ENGINE COMPRESSOR AND TURBINE SECTION HAVE SEVERE EVIDENCE OF
IN-FLIGHT FAILURE AND DAMAGE.

4. ALL SECOND STAGE COMPRESSOR ROTOR BLADES 225155 AND THIRD STAGE
229156 RECOVERED. ALL BLADES HAVE ROTATIONAL AND IMPACT DAMAGE. NO
BLADE FAILURE.
5. FOURTH, FIFTH, SIXTH, AND SEVENTH-STAGE COMPRESSOR ROTOR BLADES
DAMAGED AND BROKEN. APPROX 26 BLADES IN EACH STAGE BROKE AT THE PLATFORM.
BELIEVED CAUSED BY IMPACT.

6. EIGHTH THRU THIRTEENTH STAGE COMPRESSOR ROTOR BLADES SEVERELY
DAMAGED.
7. RECOVERED 28 SEVERELY DAMAGED INLET GUIDE VANES 222886, 28 VANES
MISSING.
8. RECOVERED 31 SEVERELY DAMAGED FIRST STAGE COMPRESSOR STATOR VANES
222501, 25 MISSING.

9. RECOVERED 44 SEVERELY DAMAGED SECOND STAGE COMPRESSOR STATOR VANES,
TWELVE MISSING.
10. LESS THAN ONE-THIRD OF COMPRESSOR CASE WAS RECOVERED. MOSTLY REAR
PORTION. SCATTERED QUANTITIES OF AFT COMPRESSOR STATOR VANES RECOVERED.

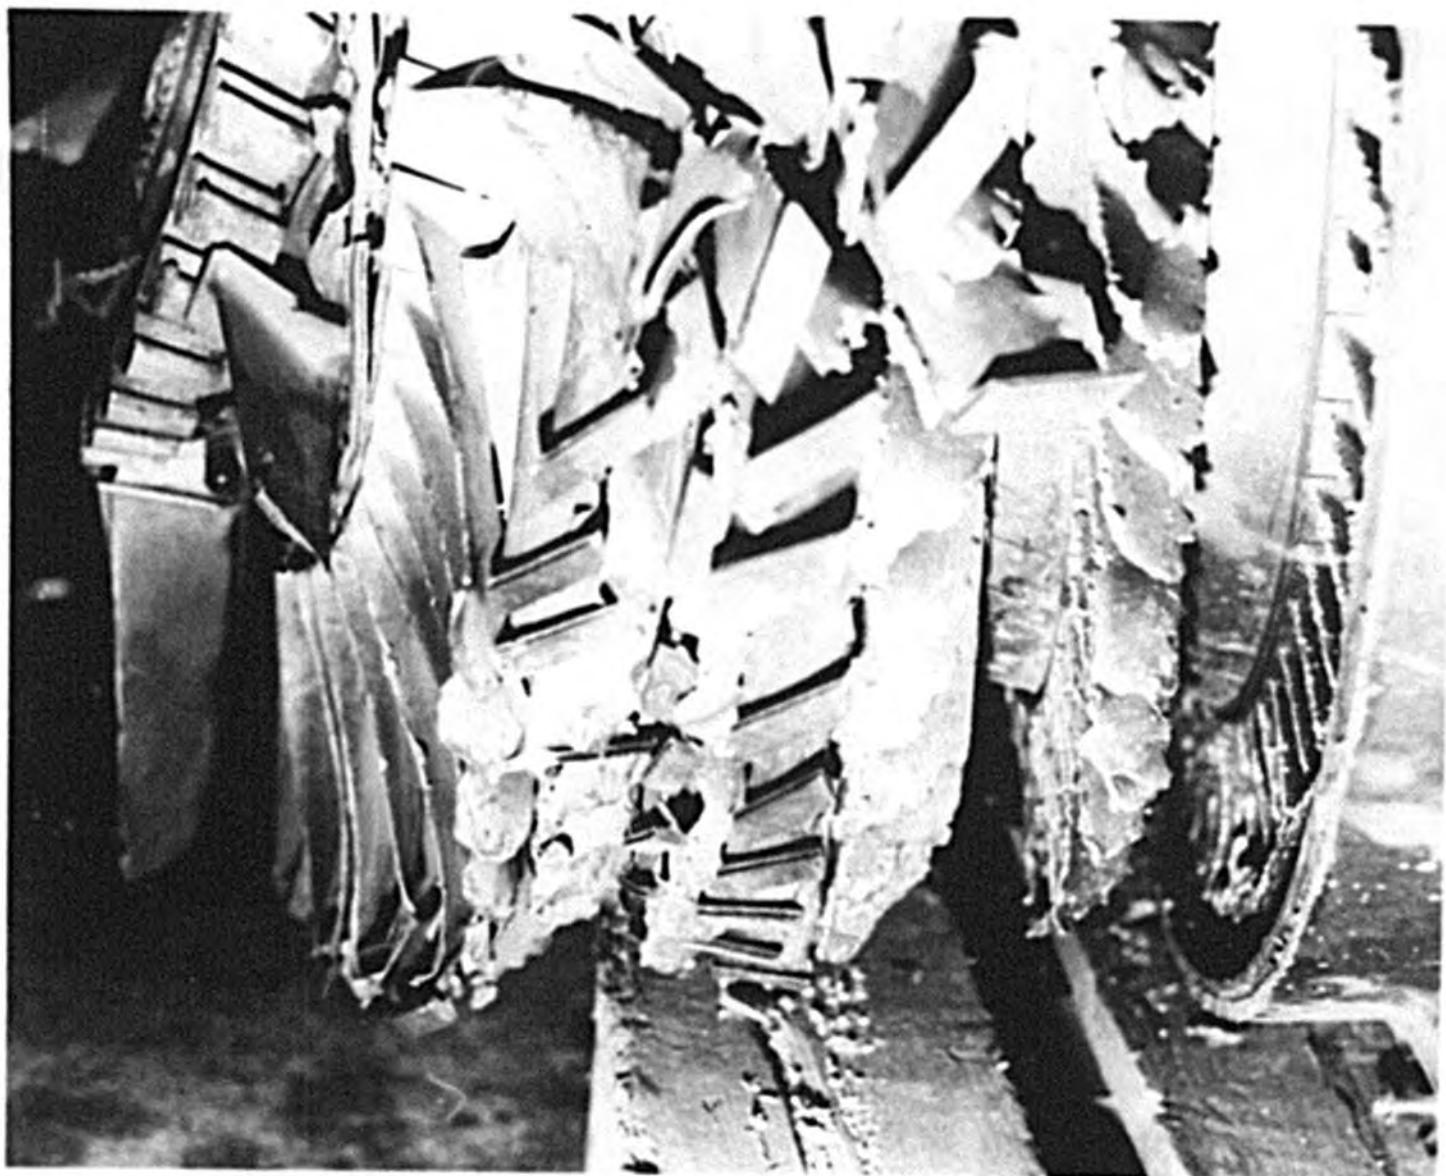
ENCLOSURE (7) 1st STAGE COMPRESSOR BLADE SUSPECTED OF FAILURE
NAS LOS ALAMITOS 3-68A, 4-17-68
A-4A, BUNO 137828, pilot SHAFER, VA-773
SPECIAL HANDLING REQUIRED IAW OPNAVINST 3750.6 SERIES

2. ENGINE SEVERELY DAMAGED AT IMPACT. EVIDENCE OF VERY LOW RPM AT
TIME OF IMPACT.
3. RECOVERED ALL BUT NINE FIRST STAGE COMPRESSOR ROTOR BLADES 231817
(J65 PPC 26). ALL BLADES SHOW ROTATIONAL AND IMPACT DAMAGE. TWO FIRST
STAGE BLADES HAD BLADE TIP BROKEN OFF APPROX 3 1/4 INCHES ABOVE BLADE
PLATFORM. BLADE TIPS NOT RECOVERED. ONE BLADE EXHIBITS A POSSIBLE
FATIGUE CONDITION. CAUSE OF THIS CONDITION UNDETERMINED. BROKEN BLADE
WITH FATIGUE INDICATIONS FORWARDED TO CURTISS WRIGHT SERVICE ENGINEERING
VIA LOREP. CURTISS WRIGHT AGREED TO FURTHER METALLURGICAL STUDY OF
BROKEN BLADE. FIRST STAGE BLADES HAVE A TOTAL OPERATING TIME OF 63.1
HOURS.

15. CONCLUDE THAT REPORTED IN-FLIGHT EXPLOSION ORIGINATED IN FRONT OF
COMPRESSOR IN AREA OF INLET GUIDE VANE AND FIRST STAGE COMPRESSOR ROTOR.
CAUSE OF COMPRESSOR FAILURE UNDETERMINED. THREE POSSIBLE CAUSES ARE
FOREIGN OBJECT DAMAGE, INLET GUIDE VANE OR CARRIER WING FAILURE, OR
FIRST-STAGE COMPRESSOR ROTOR BLADE FAILURE. METALLURGICAL INVESTIGATION
OF BROKEN FIRST STAGE COMPRESSOR ROTOR BLADE AT CURTISS WRIGHT MAY
ASSIST IN MORE POSITIVE CONCLUSIONS.
16. UNLESS INVESTIGATION AT CURTISS WRIGHT REVEALS POSITIVE FINDINGS,
THIS WILL COMPLETE ACTION THIS FACILITY YOUR CONTROL 2614-68.

13. ALL MAIN ENGINE BEARINGS WERE SATISFACTORY EXCEPT FOR IMPACT DAMAGE.
14. IAW REF D RECOMMEND NAVAIRSYSCOM TECH REP WOODRIDGE TAKE PARAGRAPH
THREE FOR ACTION. CONDUCT METALLURGICAL STUDY OF BROKEN BLADE WITH
FATIGUE CONDITIONS. UPON COMPLETION NOTIFY ALCON RESULTS OF FINDINGS
UNDER YOUR CONTROL 2614-68. FORWARD BROKEN BLADE AND ANY BLADE
SPECIMENS TO NAVAVNSAFECEN NORVA. ACCIDENT INVESTIGATION DIVISION,
ATTENTION MR. (b) (6)

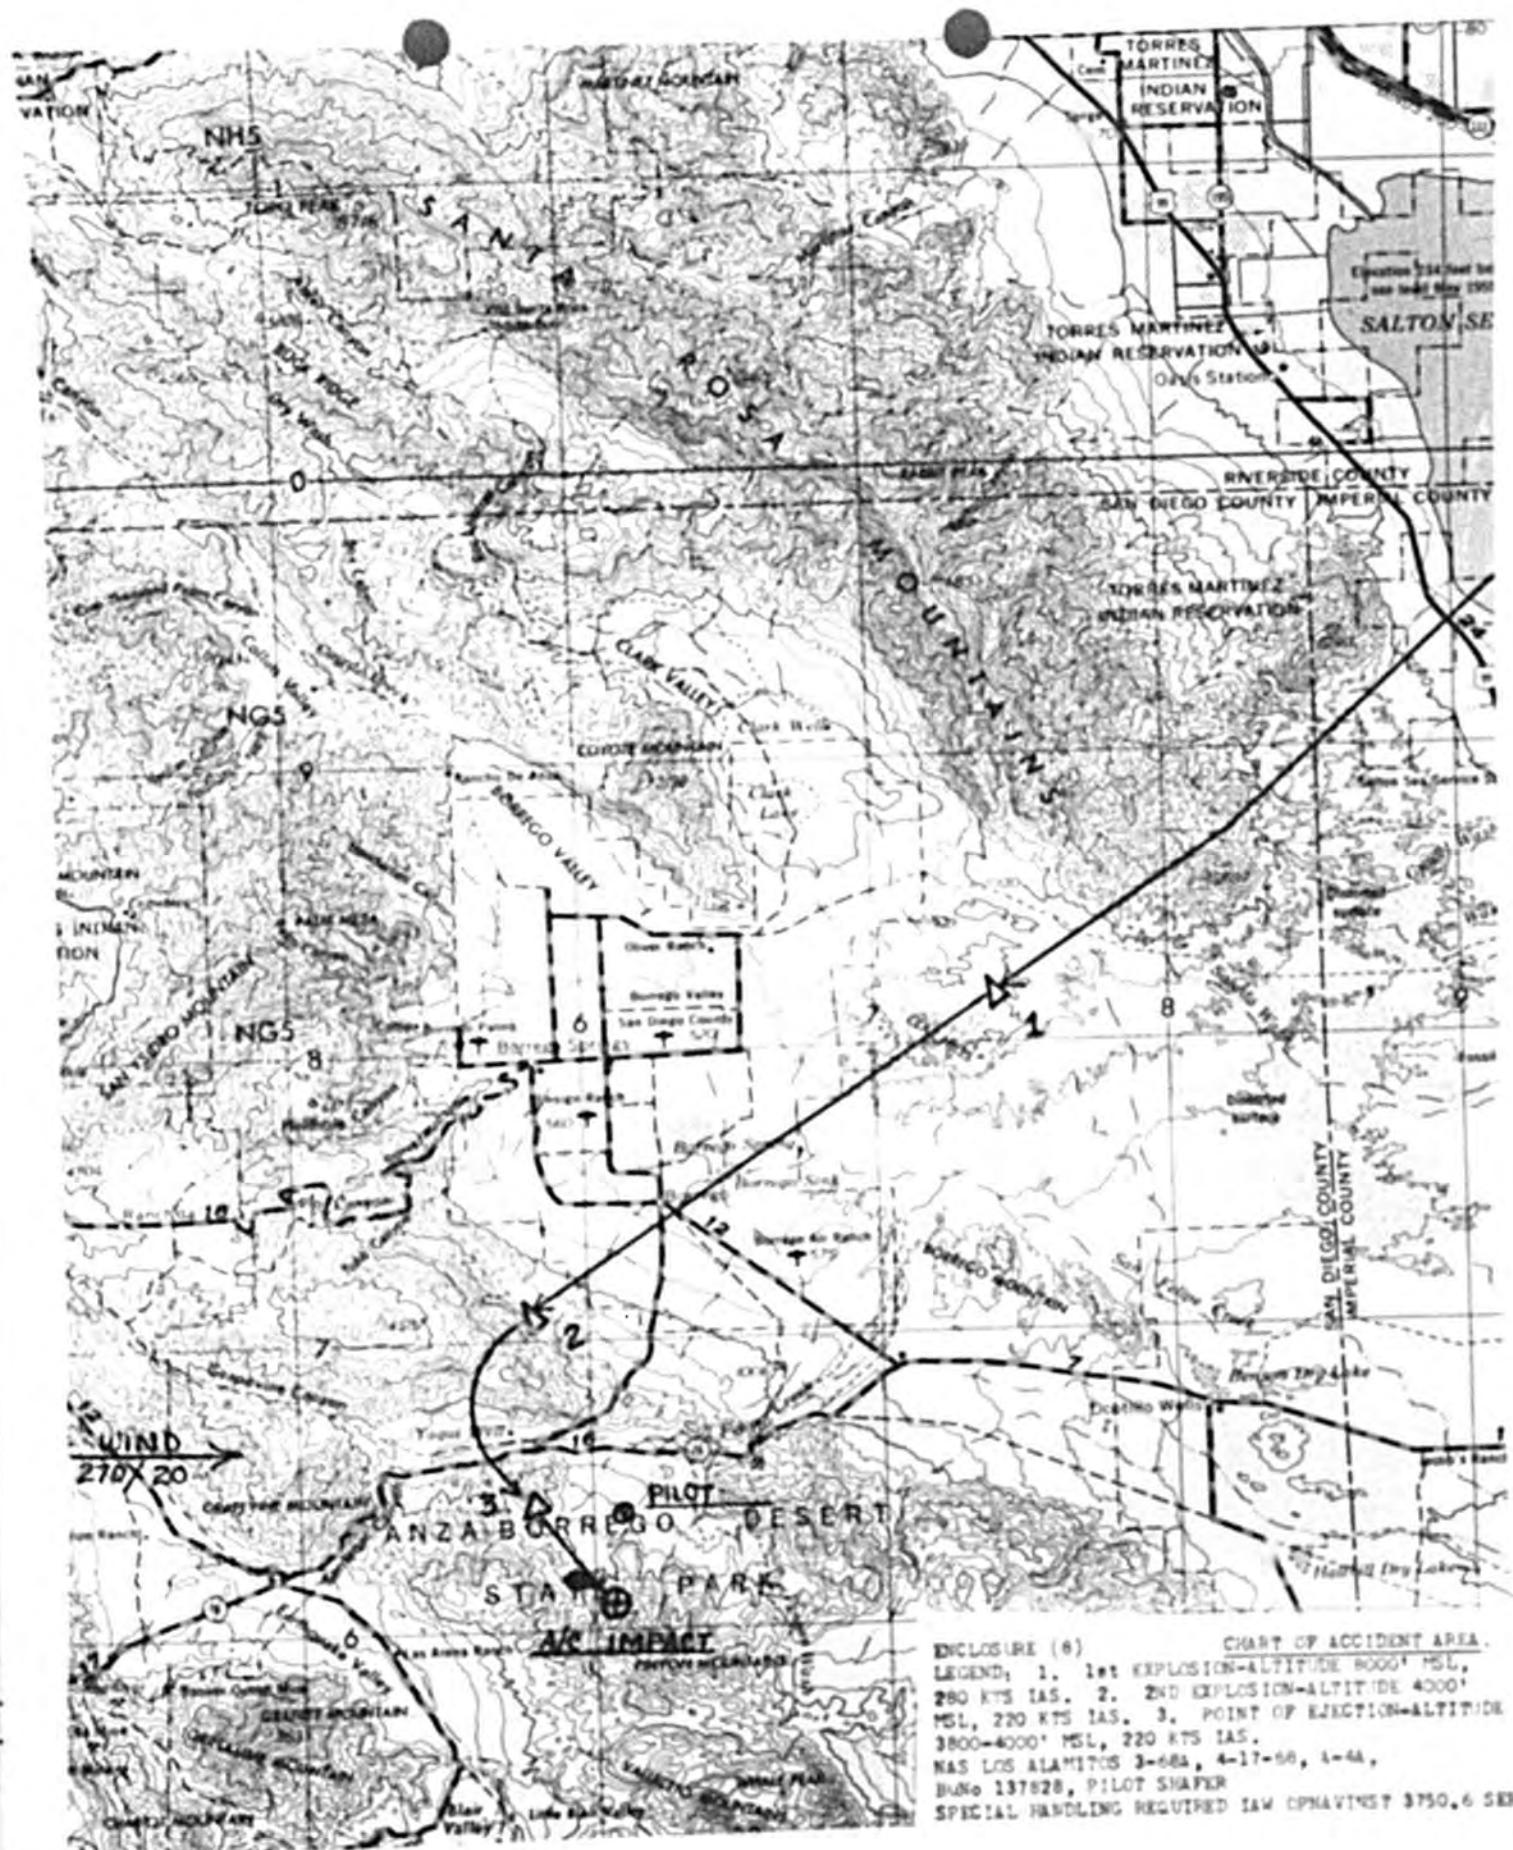
ENCLOSURE (6)

CHART OF ACCIDENT AREA.

LEGEND: 1. 1st EXPLOSION-ALTITUDE 8000' MSL,
280 KTS TAS. 2. 2ND EXPLOSION-ALTITUDE 4000'
MSL, 220 KTS TAS. 3. POINT OF EJECTION-ALTITUDE
3800-4000' MSL, 220 KTS TAS.
NAS LOS ALAMITOS 3-684, 4-17-68, 4-44,
BONO 137828, PILOT SHAFER
SPECIAL HANDLING REQUIRED IAW CPHAVINST 3750.6 SERIES

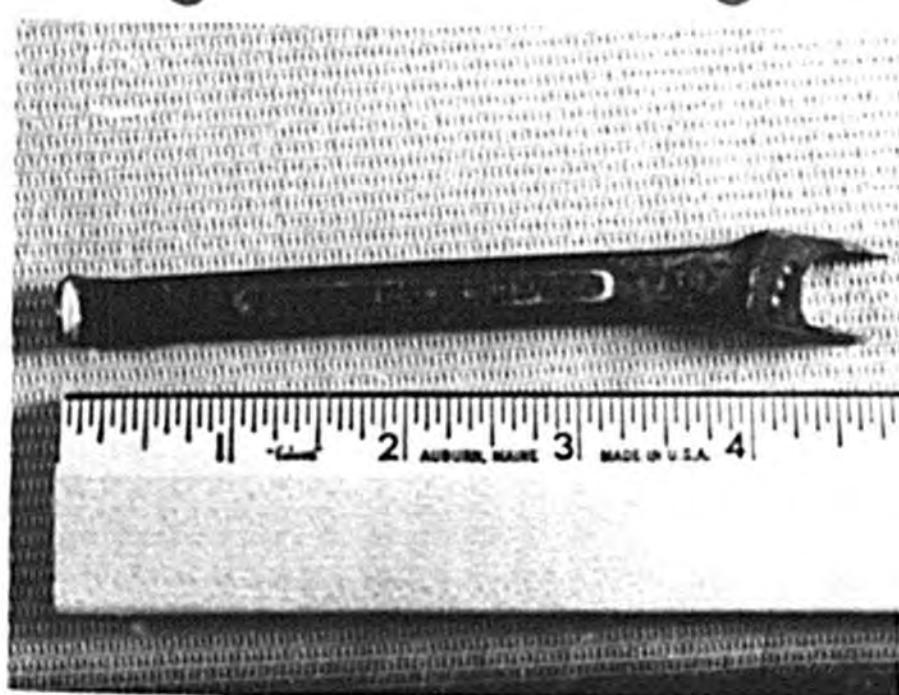
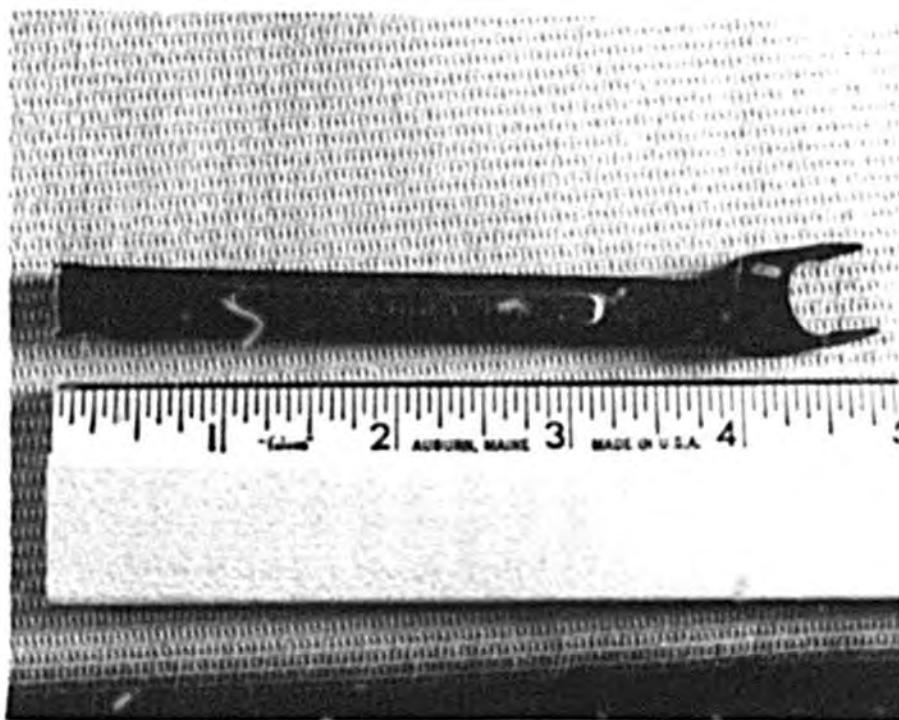
ENCLOSURE (10) WRENCH FOUND AT IMPACT POINT
NAS LOS ALAMITOS 3-68A, 4-17-68
ADIA, BUNO 137828, PILOT SHAFER
SPECIAL HANDLING REQUIRED IAW OPNAVINST 3750.6 SERIES
